SURETIGHT
INSULATED PANELS
BUILD SMARTER. LIVE BETTER.

COMMON ERRORS

SIPS-2

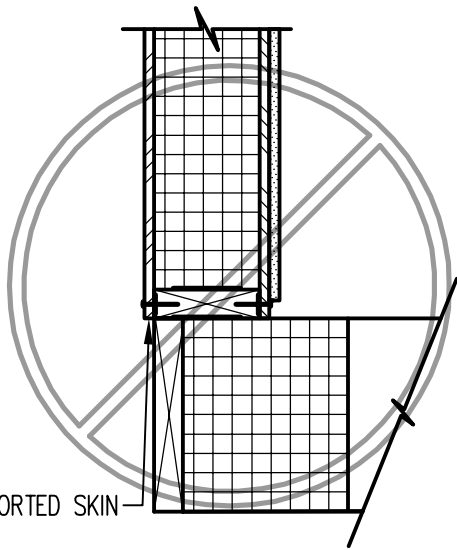
UNSUPPORTED SKIN

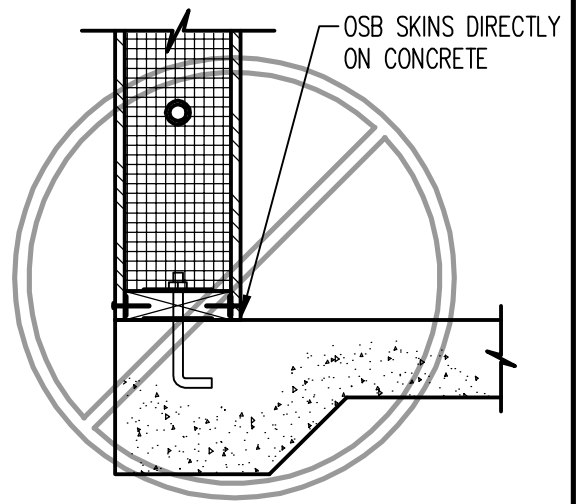
OSB SKINS DIRECTLY ON CONCRETE

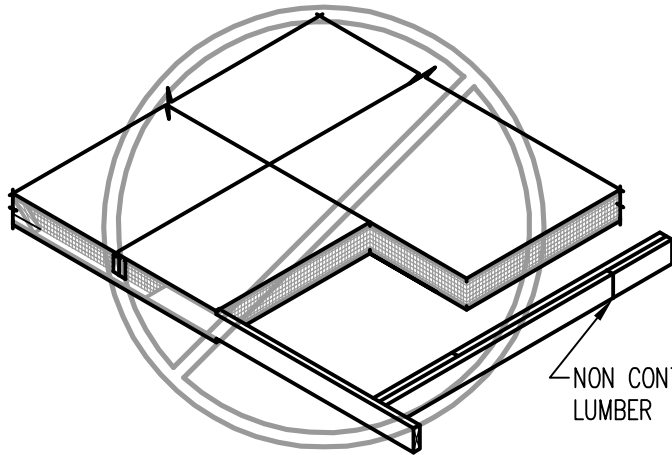
NON CONTINUOUS LUMBER

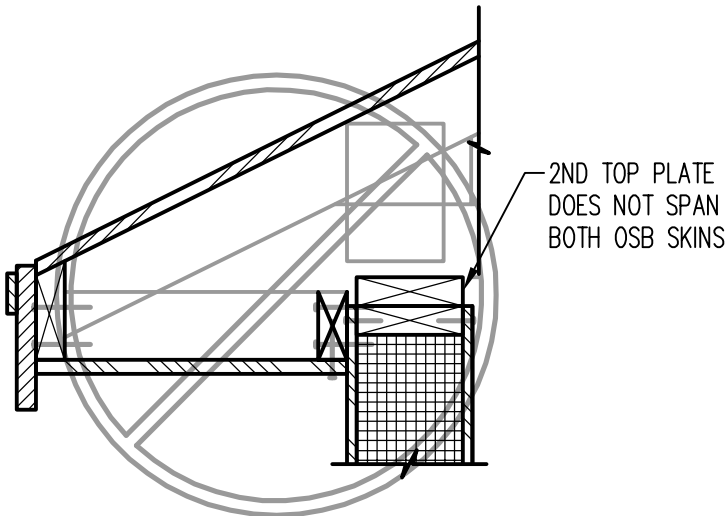
2ND TOP PLATE DOES NOT SPAN BOTH OSB SKINS

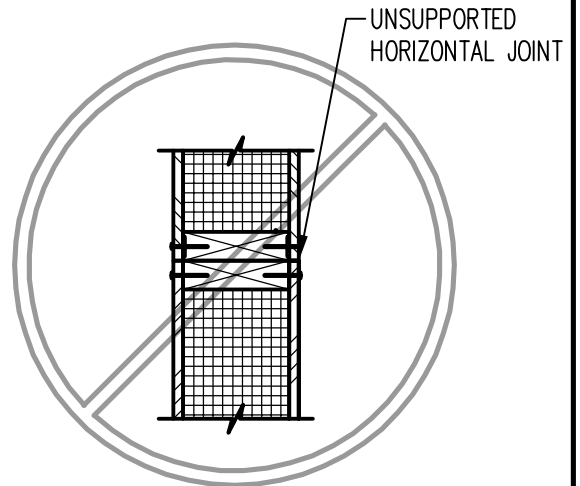
UNSUPPORTED HORIZONTAL JOINT
